A Trip to Great Bear Lake

Historic Mine Site Investigations
Including Contact Lake, Port Radium, Elbonanza,
Bonanza, Crossfault Lake, and Cameron Bay

July 2005

Ryan Silke

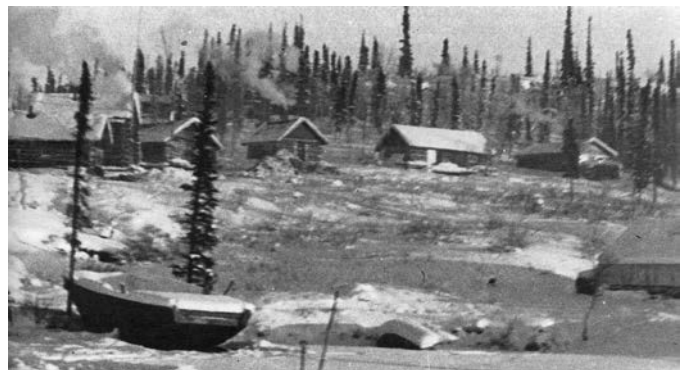
Contact Lake camp buildings, c.1938
(from Yellowknife: An Illustrated History...misidentified as
Burwash Yellowknife Camp)
